UTAH TANK NEWS

Summer 2012

Underground Storage Tank Branch

SUCCESSES - Bullfrog Marina

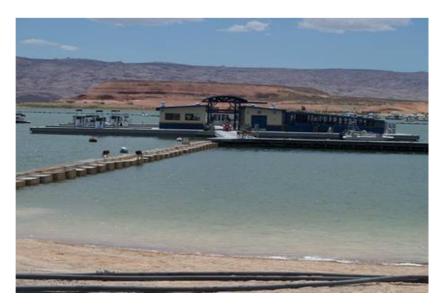
If you have a chance to visit beautiful Lake Powell via Bullfrog Marina take a close look at all the engineering that has gone into their fuel facility. Their USTs and ¾ of a mile of underground piping have been replaced by 3 double-walled ASTs located on a floating tertiary containment structure. All piping and tanks are double-walled; leak detection consists of sump monitoring (for dispensers) and interstitial monitoring for tanks and piping. Overfill protection is by way of Overfill Protection Device (OPD), Veeder Root high level alarm plus an electric solenoid valve which closes if the overfill alarm sounds. All piping is accessible from the topsides of the dock through FRP fibergrate panels covering the chases.

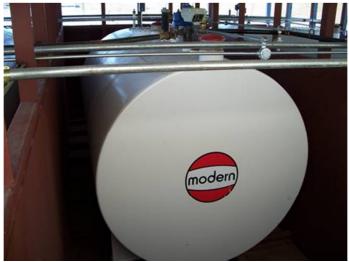
This small diesel tank sits between the 2 larger gasoline tanks. Each tank has its own independent enclosure within the floating tertiary containment structure. The ASTs are filled from a shore-side tanker through a loading manifold on the beach which is equipped with spill containment and double-walled piping to the ASTs.
